## ABBREVIATED PRELIMINARY ASSESSMENT CHECKLIST

**Site Name:** 100 Commercial Street

**Site Location:** 100 Commercial Street  
 (Street)

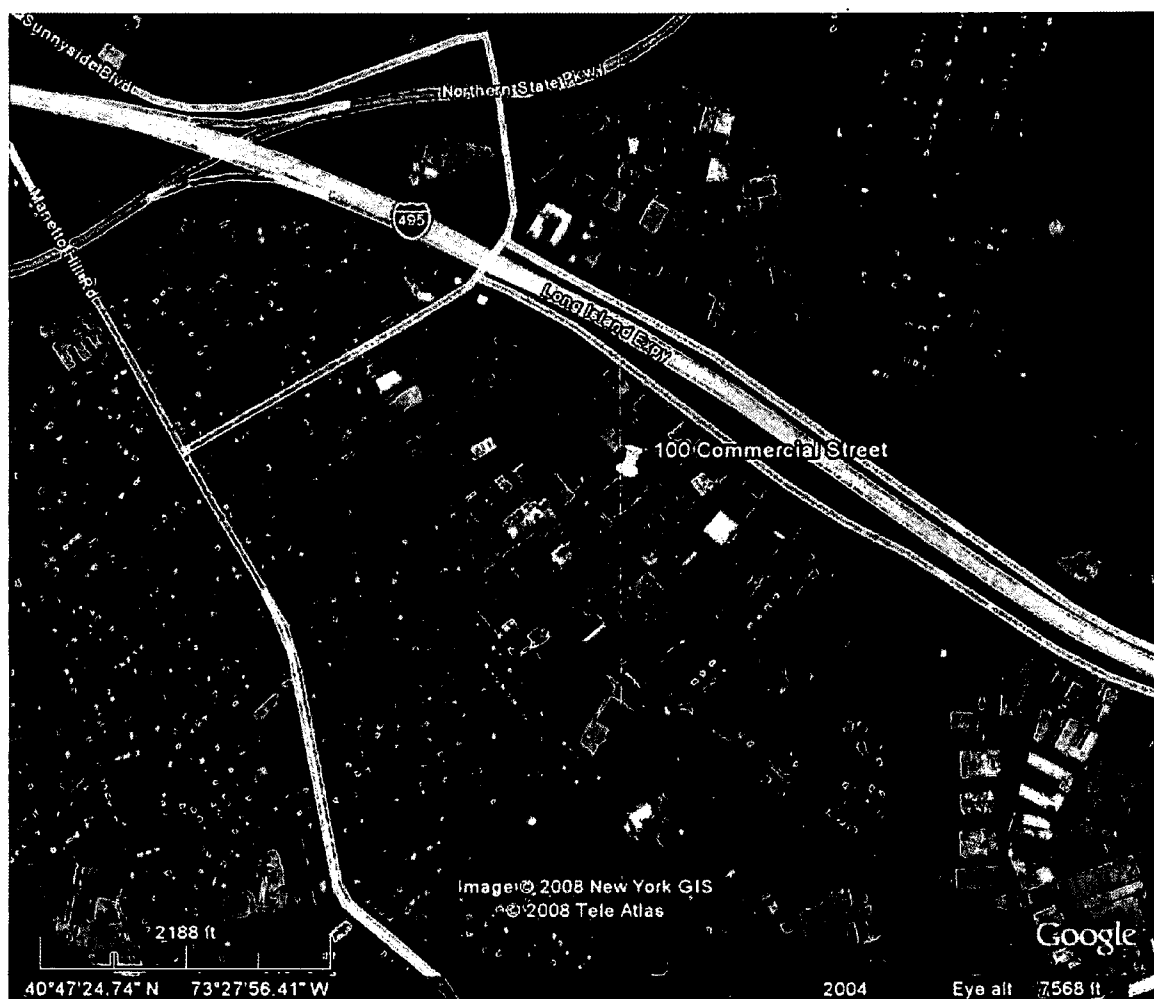
Figure 1. 100 Commercial Street, Plainview, NY

The 100 Commercial Street site consists of a single story 72,000 square foot masonry building built in 1961 in Plainview, Nassau County, New York. The site is located in an industrial/commercial park surrounded by a residential area (Figure 1). Discharges of tetrachloroethane and trichloroethane into an onsite leaching pool led to the contamination of subsurface soil and groundwater. Groundwater is at a depth of approximately 100 feet in the area.
